Technical Service Bulletin

Title: **TRANSAXLE WHINE NOISE**

Models: '06-'10 RAV4

DRIVELINE
TSB3415

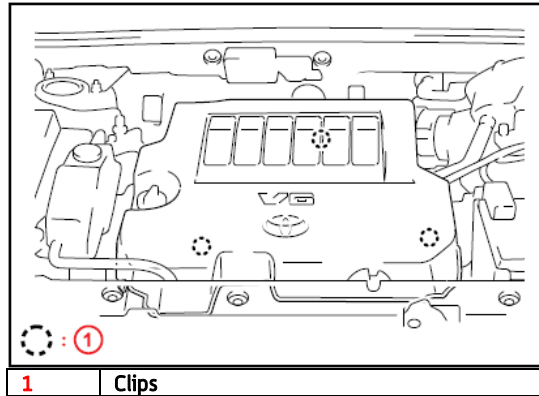
Figure 1.

- (1) Remove the V-bank cover sub-assembly by detaching the 3 clips.

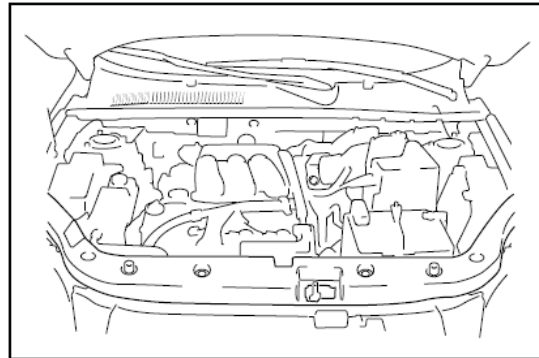
Figure 2.

- (2) Remove the radiator support opening cover by removing the 9 clips.

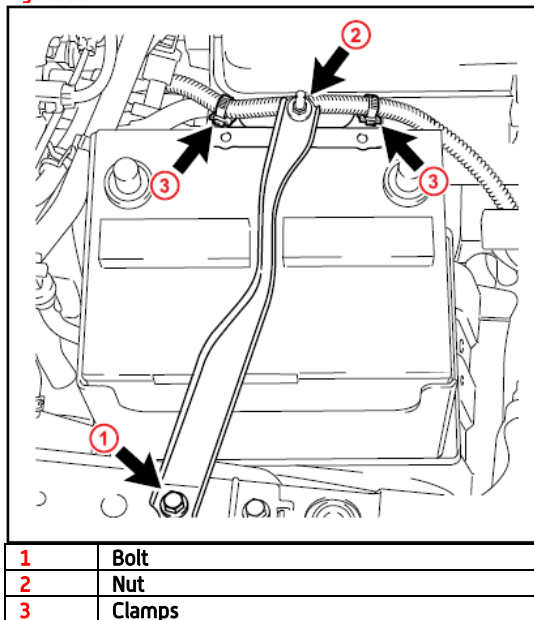
Figure 3.

- (3) Remove the battery clamp sub-assembly.
 1. Remove the bolt and loosen the nut.
 2. Detach the 2 wire harness clamps.
 3. Detach the hook of the battery clamp from the battery bracket front, and then remove the battery clamp.

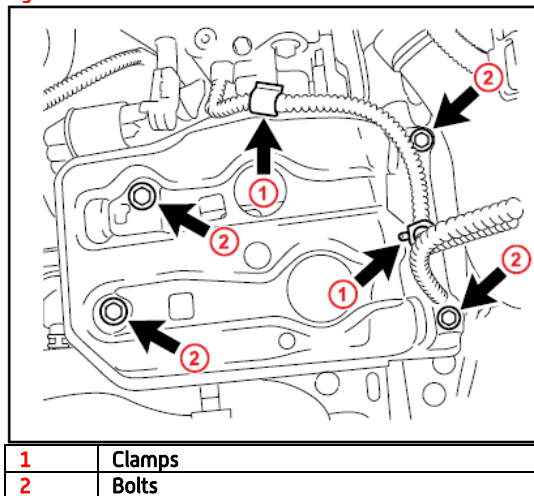
Figure 4.

- (4) Remove the battery.
- (5) Remove the front battery bracket.
 1. Detach the 2 wire harness clamps.
 2. Remove the 4 bolts and front bracket

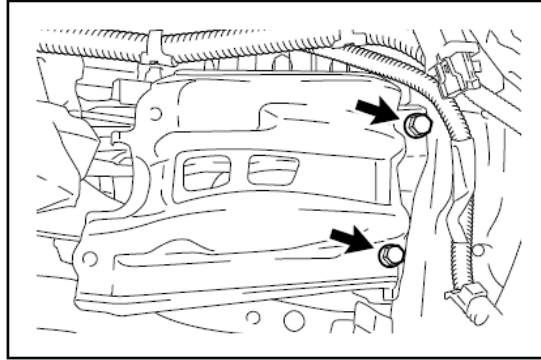
Figure 5.

- (6) Remove the battery bracket reinforcement by removing the 2 bolts.

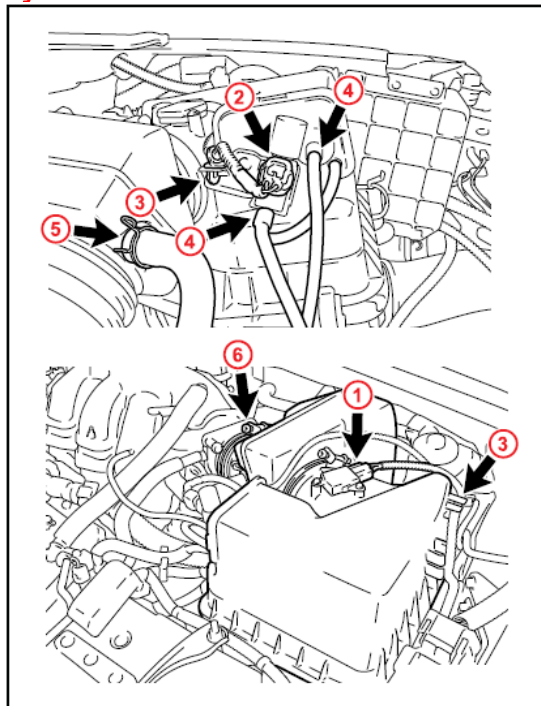
Figure 6.

- (7) Remove the air cleaner cap sub-assembly.
 1. Disconnect the mass air flow meter connector.
 2. Disconnect the VSV (air intake control) connector.
 3. Disconnect the wire harness clamp and 2 vacuum hoses.
 4. Disconnect the No. 2 ventilation hose from the air cleaner hose.
 5. Loosen the No. 1 air cleaner hose clamp.
 6. Unfasten the 2 hook clamps, and then remove the air cleaner cap.
 7. Remove the air cleaner filter element from the air cleaner case.

1	Mass Air Flow Meter Connector
2	Purge VSV Connector
3	Wire Harness Clamp
4	Vacuum Hoses
5	No. 2 Ventilation Hose Clamp
6	No. 1 Air Cleaner Hose Clamp

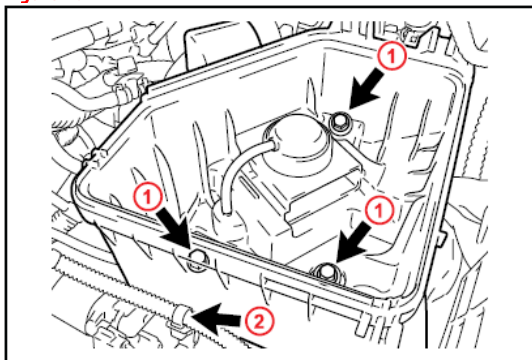
Figure 7.

- [8] Remove the air cleaner case.
 - 1. Disconnect the harness clamp.
 - 2. Remove the 3 bolts and air cleaner case.
 - 3. Remove the wire harness clamp.

1	Bolt
2	Wire Harness Clamp

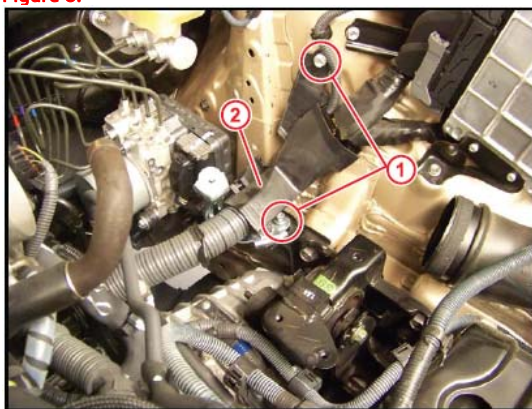
Figure 8.

- [9] Remove the 2 bolts and bracket for the engine harness.

This will improve access to the engine mounting insulator LH.

1	Bolt
2	Bracket

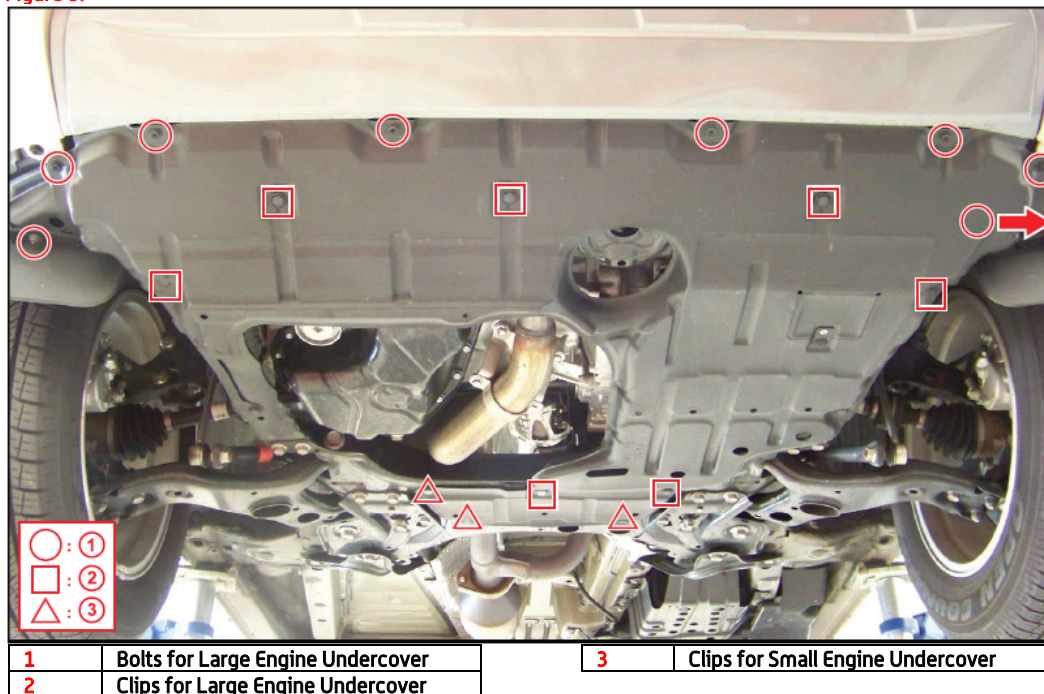
Figure 9.

- [10] Raise the vehicle and remove the engine undercovers.
 - 1. Remove the 8 plastic clips, 8 bolts, and the large engine undercover.
 - 2. Remove the 3 plastic clips and the small engine undercover.
 - 3. Lower the vehicle.

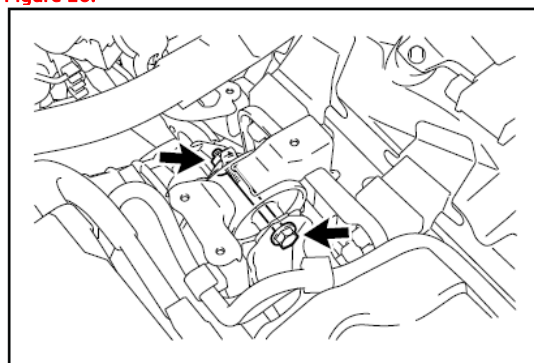
Figure 10.

- [11] Using a hydraulic jack with a rubber pad or wood block, gently support the engine/transaxle assembly to remove the load from the bolt and nut of the engine mounting insulator LH.
- [12] Remove the bolt and nut, and disconnect the engine mounting insulator LH.

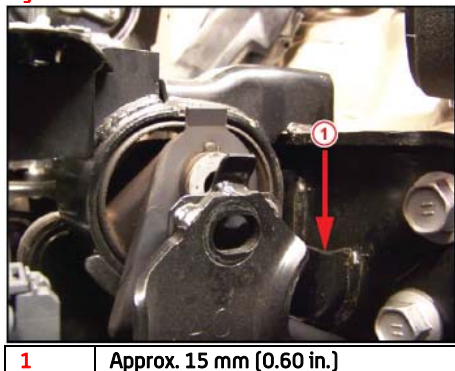
Figure 11.

- [13] Remove the 4 bolts and engine mounting insulator LH.
- [14] Install the NEW engine mounting insulator LH with the 4 bolts.
Torque: 97 N*m (990 kgf*cm, 72 ft*lbf)

It may be necessary to lower the engine/transaxle assembly up to 15 mm (0.60 in.) to improve access to the lower rear bolt with a torque wrench.

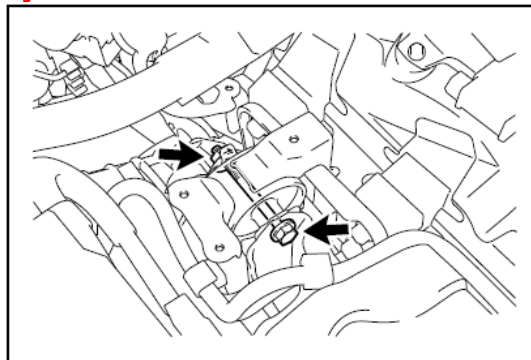
Figure 13.

- [15] Install the bolt and nut, and connect the engine mounting insulator LH.
Torque: 56 N*m (571 kgf*cm, 41 ft*lbf)

While holding the bolt in place, tighten the nut.

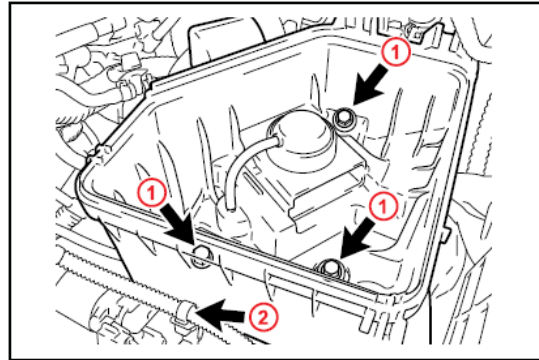
Figure 14.

[17] Install the air cleaner case.

1. Install the 3 bolts and air cleaner case.

Torque: 5.0 N*m (51 kgf*cm, 44 in*lb)

2. Connect the harness clamp.

1	Bolt
2	Wire Harness Clamp

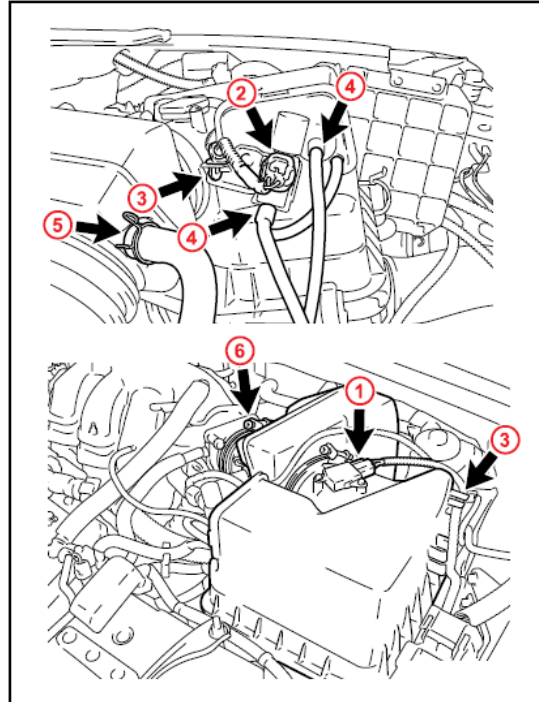
Figure 15.

[18] Install the air cleaner cap sub-assembly.

1. Install the air cleaner filter element from the air cleaner case.
2. Fasten the 2 hook clamps, and then the air cleaner cap.
3. Tighten the No. 1 air cleaner hose clamp.
4. Connect the No. 2 ventilation hose from the air cleaner hose.
5. Connect the wire harness clamp and 3 vacuum hoses.
6. Connect the VSV (air intake control) connector.
7. Connect the mass air flow meter connector.

1	Mass Air Flow Meter Connector
2	Purge VSV Connector
3	Wire Harness Clamp
4	Vacuum Hoses
5	No. 2 Ventilation Hose Clamp
6	No. 1 Air Cleaner Hose Clamp

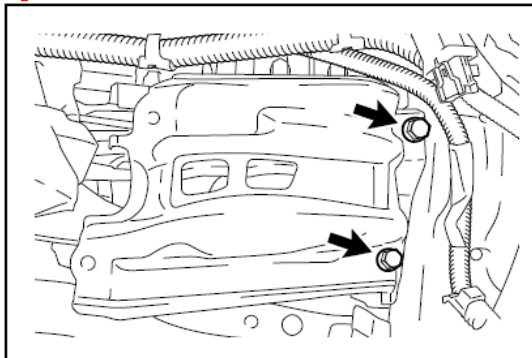
Figure 16.

- [19] Install the 2 bolts and the battery bracket reinforcement.

Torque: 19 N*m (194 kgf*cm, 14 ft*lbf)

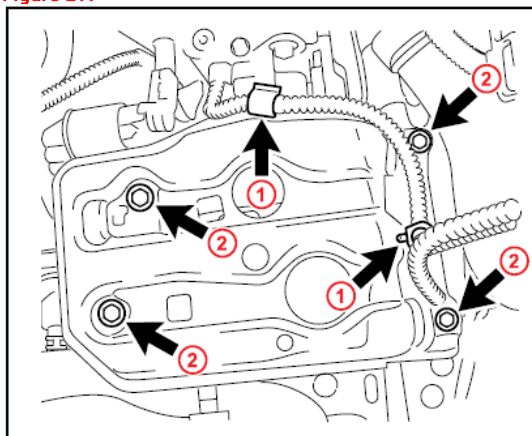
Figure 17.

- [20] Install the front battery bracket.

- 1. Install the 4 bolts and front bracket.

Torque: 19 N*m (194 kgf*cm, 14 ft*lbf)

- 2. Attach the 2 wire harness clamps.

1	Clamps
2	Bolts

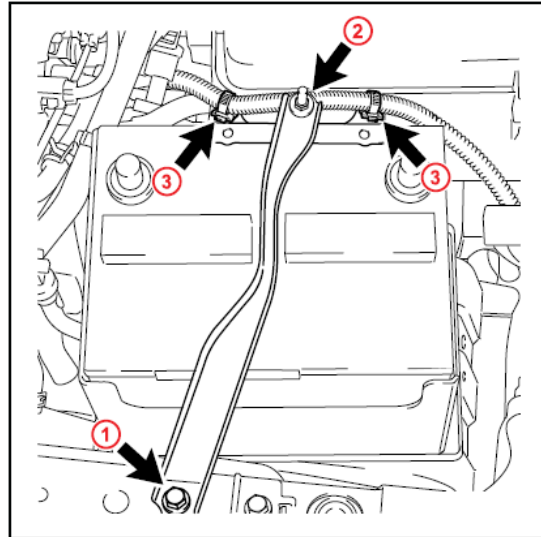
Figure 18.

- [22] Install the battery clamp sub-assembly.
1. Attach the hook of the battery clamp to the battery bracket front, and then to the battery clamp.
 2. Attach the 2 wire harness clamps.
 3. Install the bolt and nut.

Torque: 5.0 N*m (51 kgf*cm, 44 in*lb)

1	Bolt
2	Nut
3	Clamps

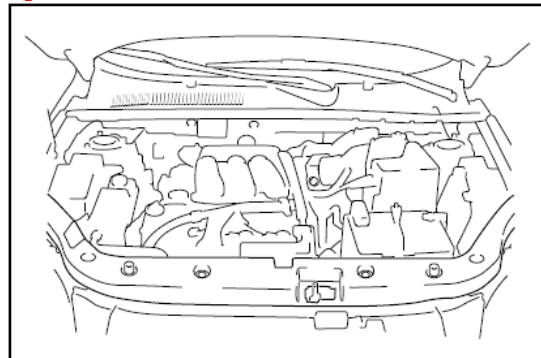
Figure 19.

- [23] Attach the radiator support opening cover and the 9 clips.

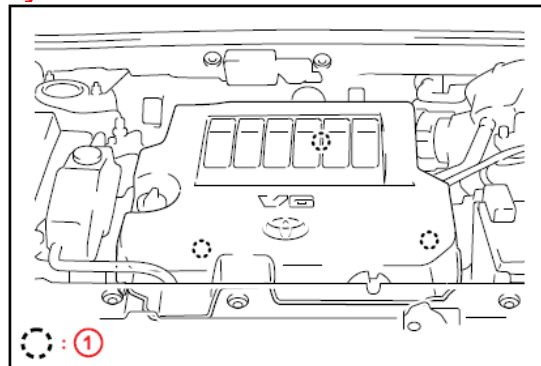
Figure 20.

- [24] Attach the V-bank cover sub-assembly and the 3 clips.

1	Clips
---	-------

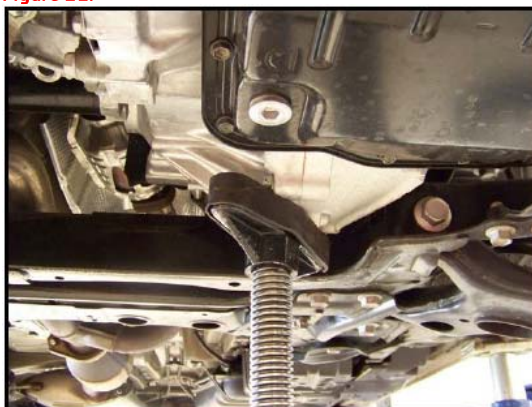
Figure 21.

- (1) Raise the vehicle and place a jack stand with a rubber cover under the transaxle case to support the engine/transaxle during removal of the bolt.

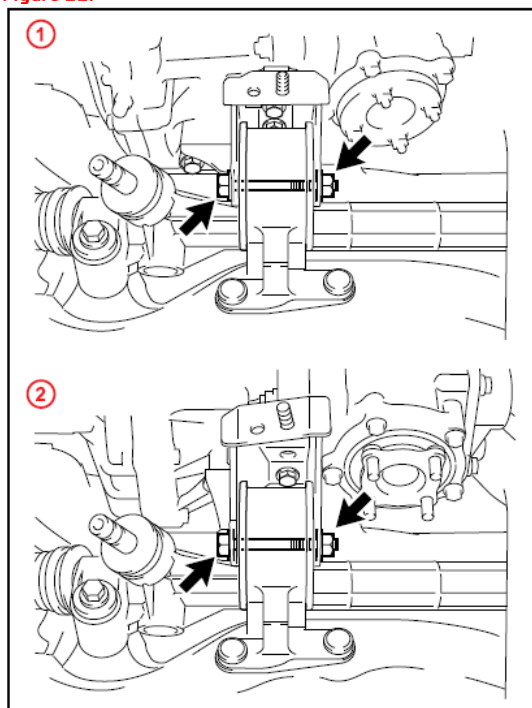
Figure 22.

- (2) Remove the bolt and disconnect the engine mounting insulator rear.

1	For 2WD
2	For 4WD

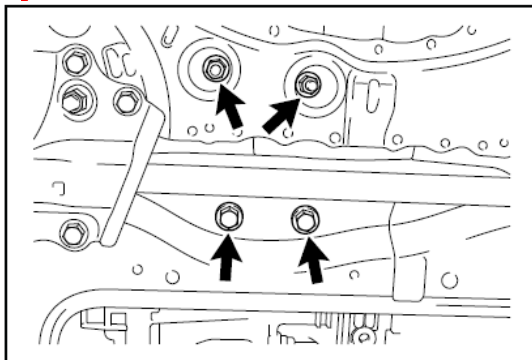
Figure 23.

- [3] Remove the 2 nuts, 2 bolts, and engine mounting insulator rear.

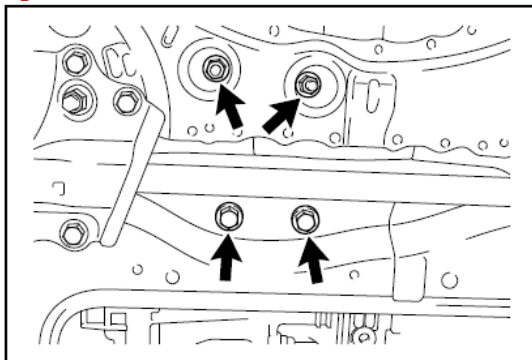
Figure 24.

- [6] Install the 2 nuts, 2 bolts, and the NEW engine mounting insulator rear.

Torque: 95 N*m (969 kgf*cm, 70 ft*lbf)

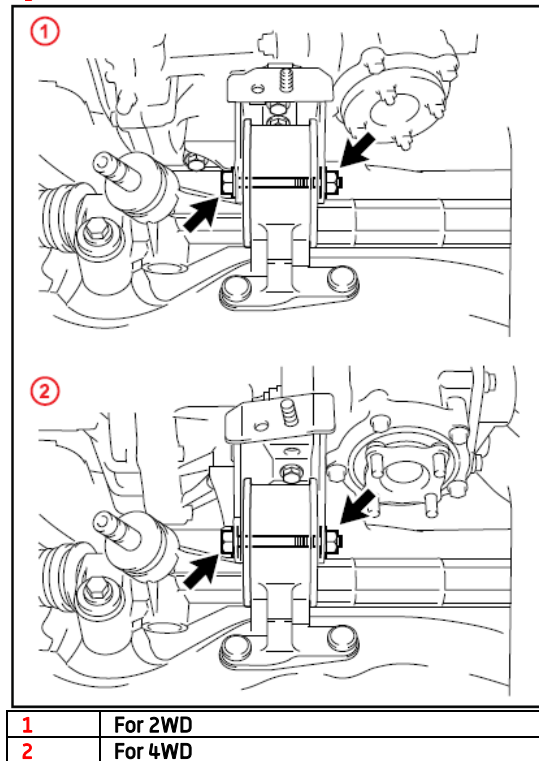
Figure 25.

- (8) Install the bolt and connect the engine mounting insulator rear.

Torque: 95 N*m (969 kgf*cm, 70 ft*lbf)

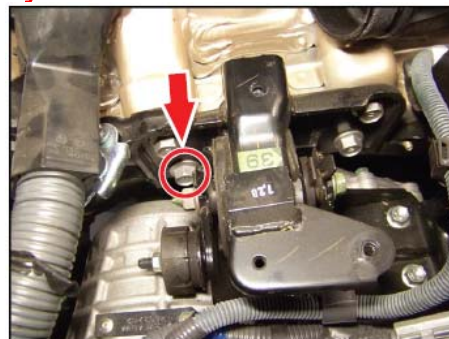
Figure 12.

- [15] Installer le boulon et l'écrou et connecter l'isolant de support de moteur G.

Couple : 56 N*m [571 kgf*cm, 41 pi*lbft]

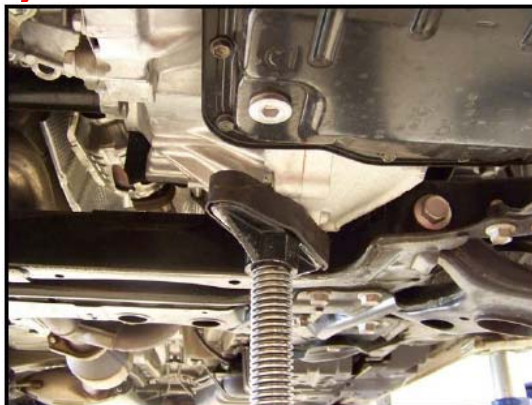
Figure 21.

- (1) Soulever le véhicule et placer un cric avec un couvercle en caoutchouc sous le carter de boîte-pont pour soutenir le moteur/boîte-pont pendant le retrait du boulon.

- (2) Retirer le boulon et déconnecter l'isolant de support de moteur arrière.

B. Replace the engine mounting insulator rear.
